TO ALL ROTORWAY HELICOPTER OWNERS
with
SINGLE CARBURETOR ENGINES

ADVISORY BULLETIN A-31

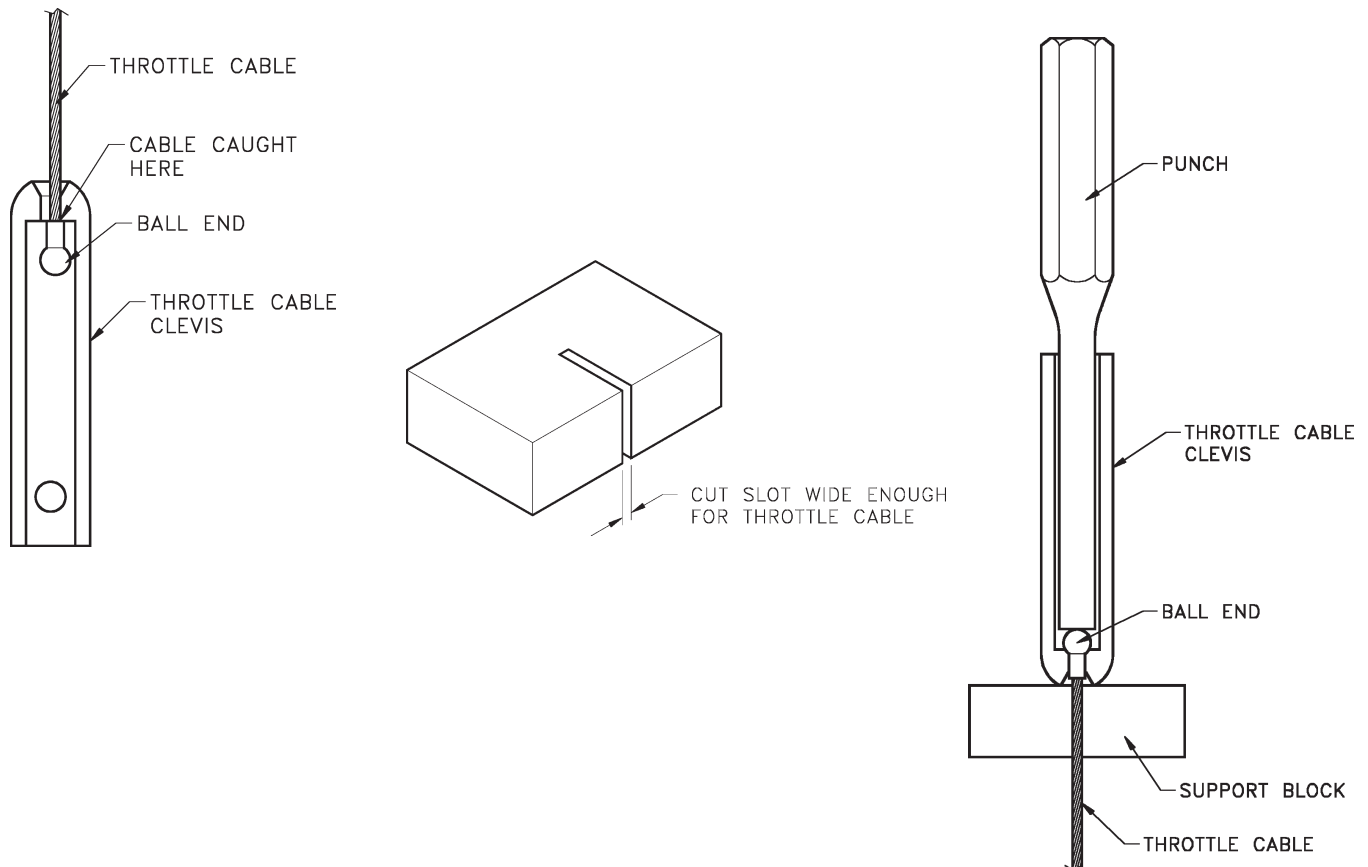
History: In some instances, the ball end of the throttle cable may catch inside the throttle cable clevis. When the cable slips free, it may cause a sudden drop in engine RPM. See illustration below (left).

Action: To check the cable, hold it against the side of the small hole in the clevis and pull outward, trying to make it catch on the edge of the small hole. If the cable catches, it will not seat correctly and you will not be able to see the shoulder of the ball in the small hole. To prevent this from happening, make a support block from a thick piece of aluminum as shown below (center). Cut a slot in the block just wide enough for the throttle cable to pass through. Place the block in a vise. Hold the cable in the seated position and place the cable in the slot, resting the clevis on the block. Insert a punch (or steel rod) into the clevis and place the tip of the punch on the ball as shown below (right). Strike the punch sharply with a hammer, causing the ball to deform the edge of the softer aluminum clevis. If necessary, repeat this process a few times until the ball no longer catches on the inside of the clevis.
