**TO ALL EXEC 162F OWNERS with  
ACIS EQUIPPED ENGINES**

**ADVISORY BULLETIN A-41**

Subject: ACIS - Altitude Compensation Induction System

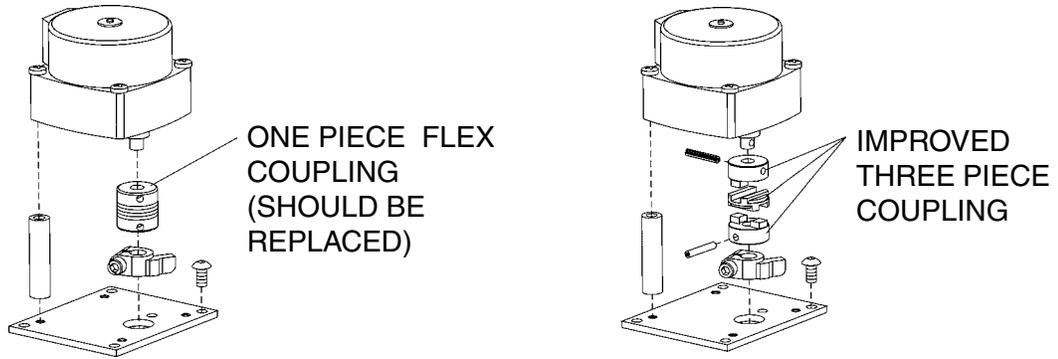
An ACIS engine differs internally from the normally aspirated engine in the design of the piston, the piston ring end gap and the compression ratio of the engine. The failures that have occurred are with the piston and piston rings. It is very likely that the pistons are getting too hot from the combustion of hot intake air and fuel. The fuel mixtures of the failed engines appear to be okay except in cases where the boost available to the intake system was too high from non-operable stepper motor control, and in these cases the fuel mixture was leaner.

- 2. The flexible coupling for the stepper motor control, used on earlier systems, should be replaced with the improved coupling. See illustration below. Use the Stepper Motor Coupling Kit, part number E38-5200.

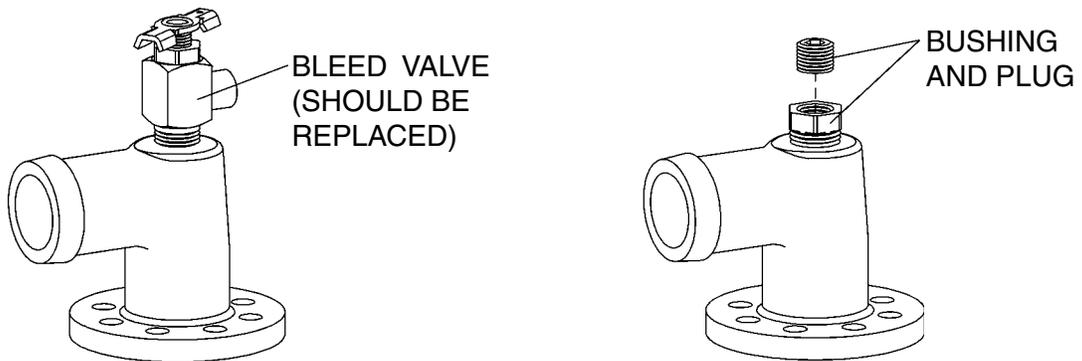
There have also been a couple of instances where the coolant bleed valve on the engine opened in flight from the supercharger belt failing and impacting the valve. In each case the valve was safety wired as recommended in Bulletin A-35 (September 21, 2000).

- 3. If the engine has a bleed valve on the passenger side waterjacket elbow, the valve should be replaced with a bushing and plug. Use the Bleed Valve Replacement Kit, part number A24-3070.
