May 20, 1996

TO ALL EXEC, EXEC 90 and EXEC 162F OWNERS

ADVISORY BULLETIN A-26

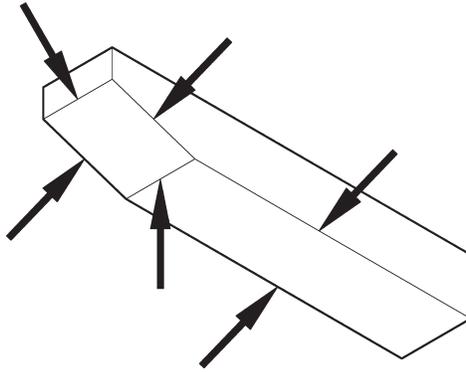
Another item of concern has been the installation of the key between the sprocket and the shaft. If the key is improperly installed, stress may be induced into the keyway area, which could develop into a crack.

Before re-installing the key, radius the edges of the key where it contacts the shaft, as indicated by the arrows in the illustration below. The edges should have approximately a 1/16" radius. This can be done using a file, grinder, or sander.
