April 4, 2002

TO ALL EXEC 90 AND EXEC 162F OWNERS

MANDATORY COMPLIANCE BULLETIN M-20

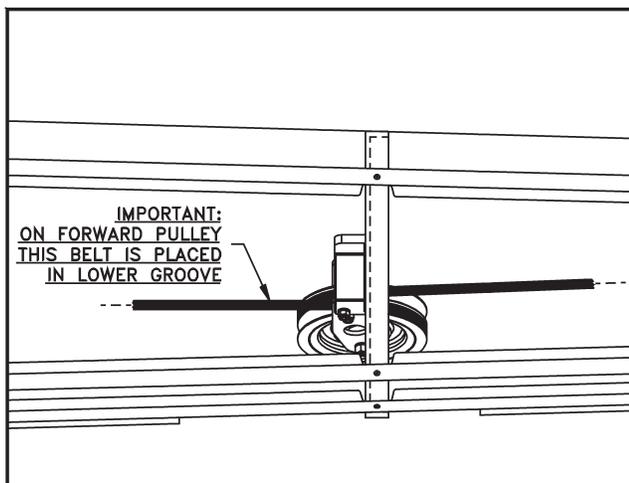
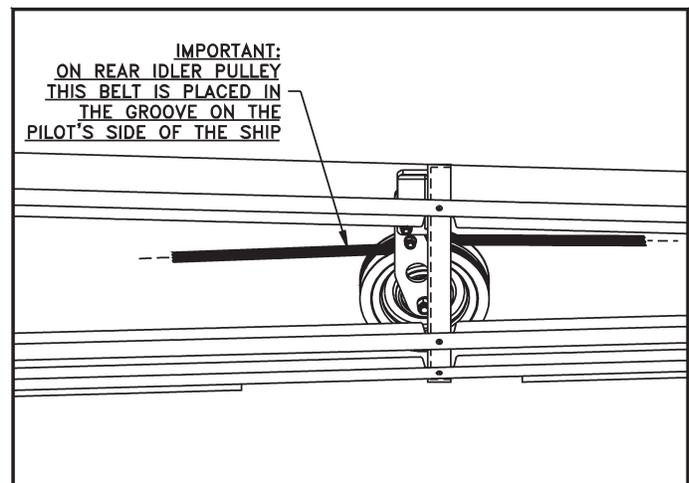
The tail rotor belts transfer power from the main drive to the tail rotor shaft. As indicated in the construction documents, the belts should be installed in specific grooves of the pulleys. (Refer to the drawings below taken from print E09-2000.)

Action: This Mandatory bulletin requires immediate inspection to verify proper routing of tail rotor drive belts through the tail boom. Removal of the tail boom inspection panels will allow for visual determination of belt routing. At the forward idler pulley, the belt coming from the secondary drive unit should be in the lowest groove of the idler pulley, and the second or middle belt should be in upper groove routing rearward. At the second idler pulley location, the second belt should route to the groove on pilot side of the aircraft, and the third belt which routes to the tail rotor shaft should be located in the upper or passenger side pulley groove.

**ANY BELT NOT PROPERLY ROUTED INTO CORRECT IDLER PULLEY GROOVE REQUIRES IMMEDIATE REPLACEMENT.**
