DATE: December 1990

TO: All Exec 90 Builders

EXEC 90 ADVISORY BULLETIN - 01

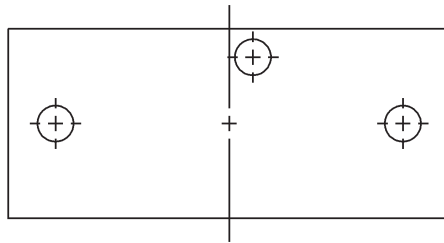
CORRECT

According to our records, your aligner blocks may have been machined incorrectly. Easy identification can be made as follows: Looking at the three tapped holes in the end of the block, the middle hole should be offset approximately 1/8" to one side.

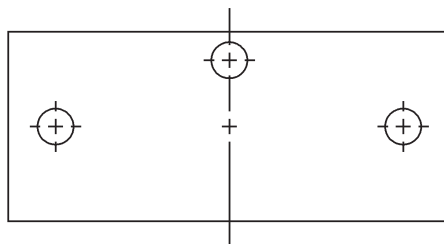
INCORRECT

If the middle hole is centered between the other two, both blocks must be returned to RotorWay for exchange.
