DATE April 4, 1991

**TO ALL EXEC BUILDERS**

**EXEC ADVISORY BULLETIN A-02**

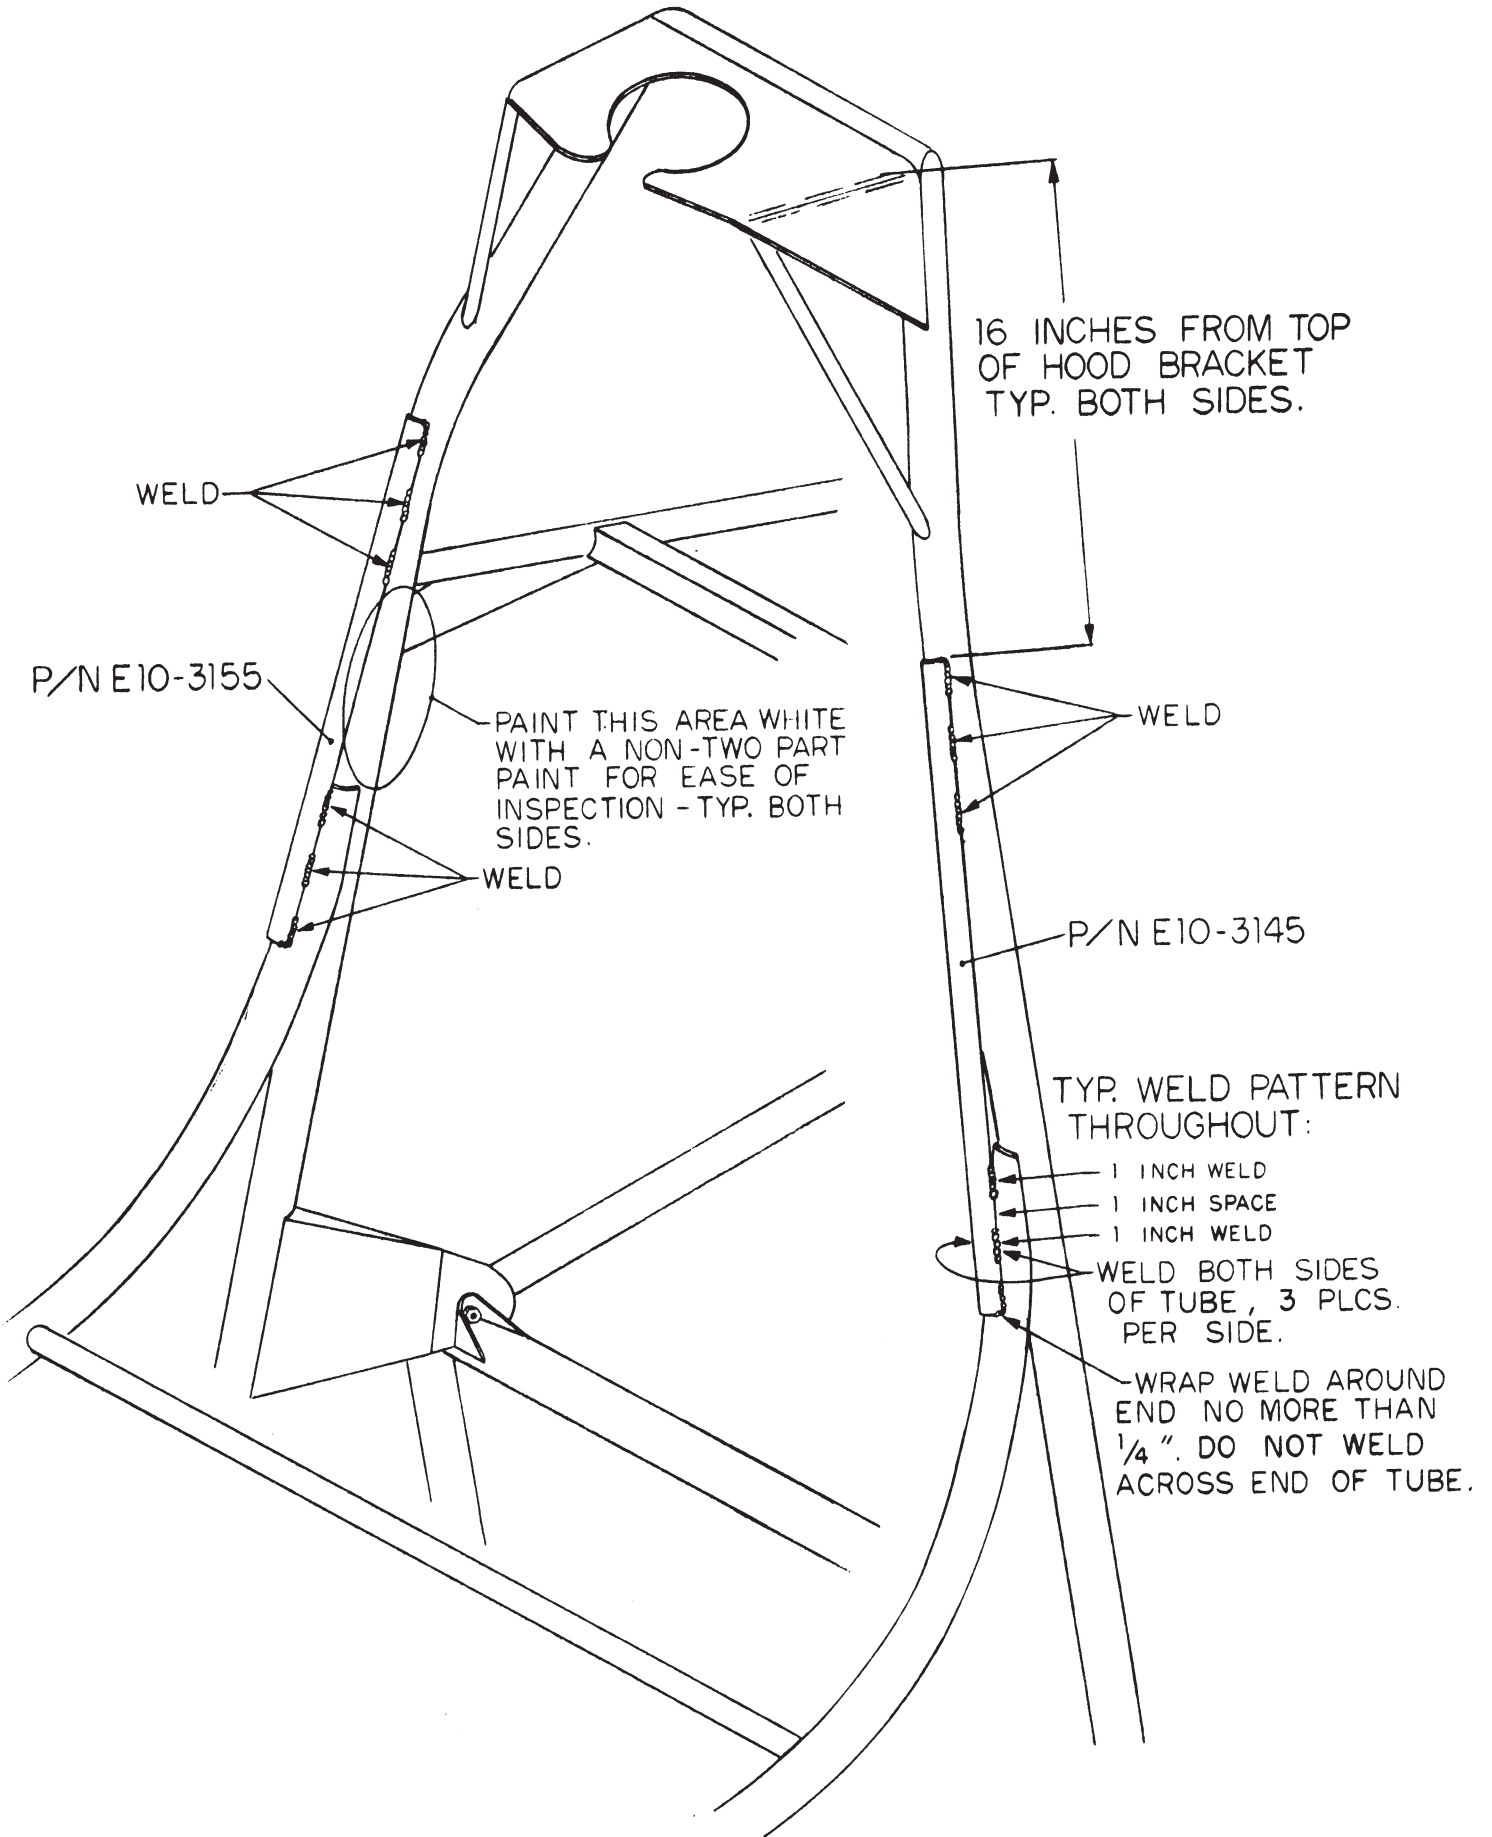
Installation of tubes E10-3145 and E10-3155 is now mandatory on EXEC 90 Airframes. These formed 1 inch diameter tubes are designed to improve the stress distribution on several sections of the airframe.

Two EXEC airframes have had the vertical support tube E10-3160 and E10-3170 fatigue and crack in half.

IT SHOULD BE NOTED THAT WHEN THESE AIRFRAME TUBES CRACK IN HALF, THE AIRFRAME SEPARATES AND REMAINS HELD TOGETHER ONLY BY THE GAS TANK STRAP. THE FRAME WILL OPEN ENOUGH THAT THE PILOT WILL LOSE CONTROL OF THE ROTOR SYSTEM. THE BLADES WILL GO TO POSITIVE PITCH THAT IS UNCORRECTABLE BY THE PILOT.

We recommend the removal of all paint around the modification area. After the welding is complete, use a thin coat of a light color single part paint to facilitate airframe crack inspection.
