April 4, 2002

TO ALL EXEC OWNERS
ADVISORY BULLETIN A-36

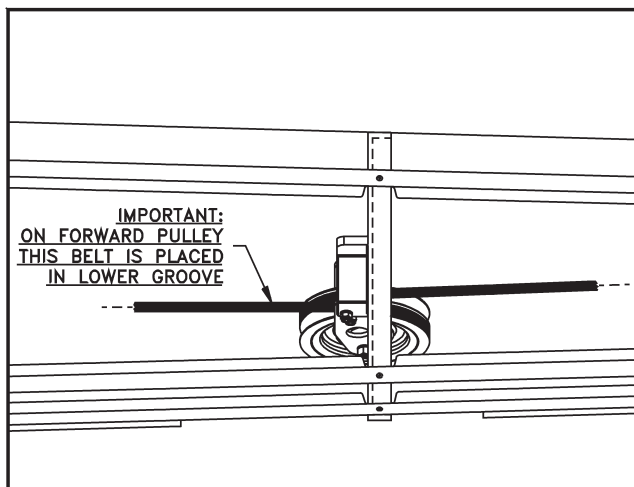
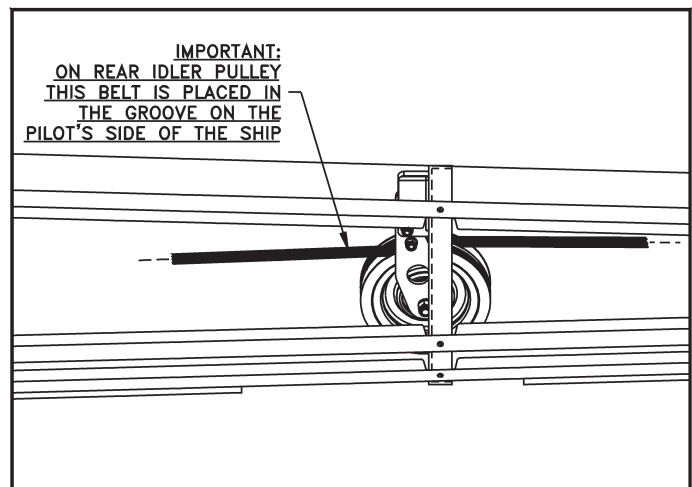
History: Recently an accident occurred due to loss of tail rotor control. During the teardown inspection, the middle or second tail rotor belt was found separated in several pieces and the belt cords were wrapped in the groove of the rear idler pulley. There is a strong opinion that the belts were not routed properly from one pulley to the next pulley, because the cords from the separated belt were wrapped in the pulley groove intended for the rear tail rotor belt.

The tail rotor belts transfer power from the main drive to the tail rotor shaft. As indicated in the construction documents, the belts should be installed in specific grooves of the pulleys. (Refer to the drawings below taken from print E09-2000.)

Action: This bulletin strongly recommends immediate inspection to verify proper routing of tail rotor drive belts through the tail boom. Removal of the tail boom inspection panels will allow for visual determination of belt routing. At the forward idler pulley, the belt coming from the secondary drive unit should be in the lowest groove of the idler pulley, and the second or middle belt should be in upper groove routing rearward. At the second idler pulley location, the second belt should route to the groove on pilot side of the aircraft, and the third belt which routes to the tail rotor shaft should be located in the upper or passenger side pulley groove.

If belts are routed properly there is no further action required.

ANY BELT NOT PROPERLY ROUTED INTO CORRECT IDLER PULLEY GROOVE SHOULD BE REPLACED IMMEDIATELY.
