March 3, 1998

TO ALL EXEC 90 AND EXEC 162F OWNERS

MANDATORY COMPLIANCE BULLETIN M-16

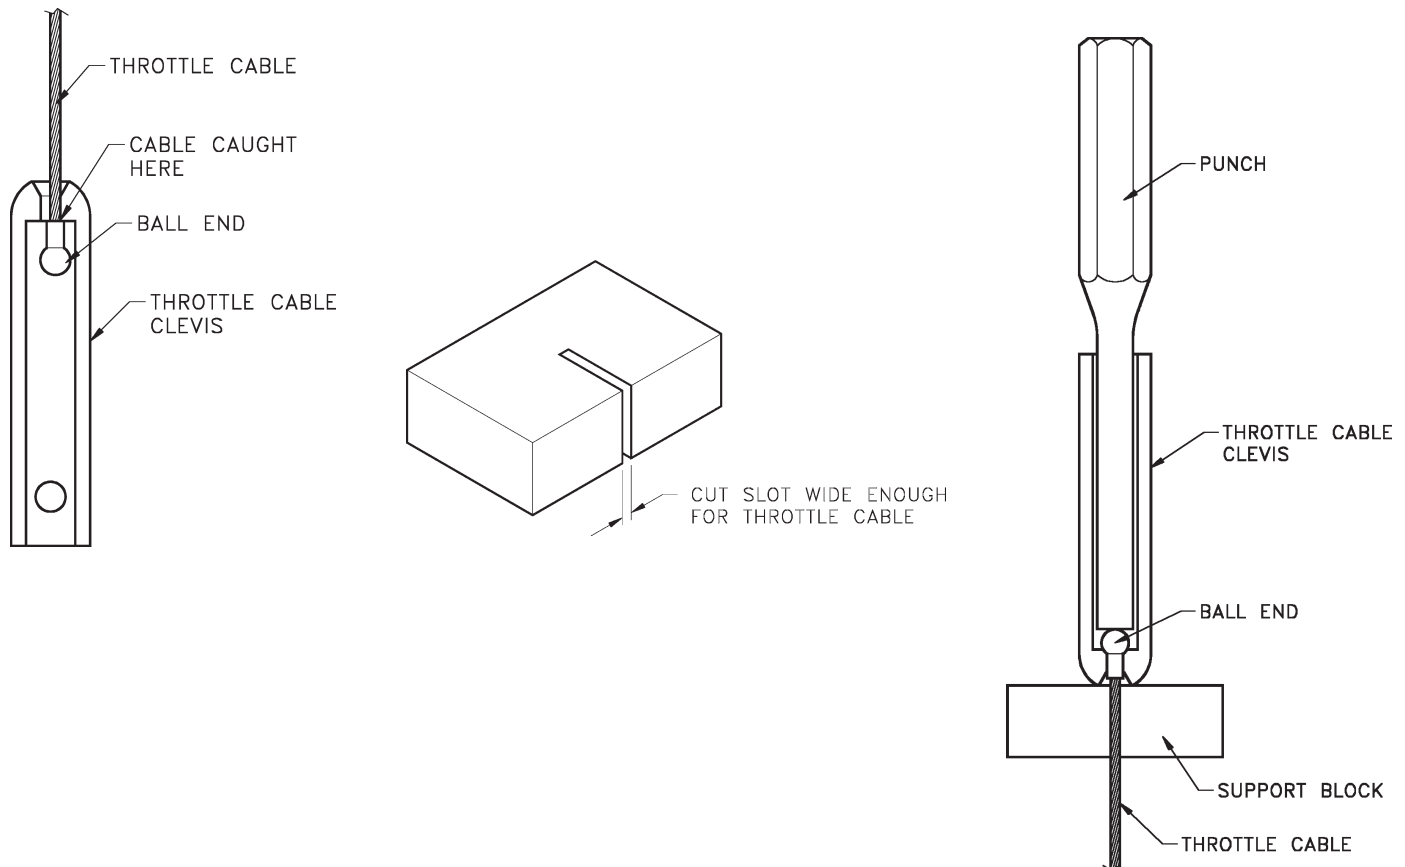
History: In some instances, the ball end of the throttle cable may catch inside the throttle cable clevis. When the cable slips free, it may cause a sudden drop in engine RPM. See illustration below (left).

Action: To check the cable, hold it against the side of the small hole in the clevis and pull outward, trying to make it catch on the edge of the small hole. If the cable catches, it will not seat correctly and you will not be able to see the shoulder of the ball in the small hole. To prevent this from happening, make a support block from a thick piece of aluminum as shown below (center). Cut a slot in the block just wide enough for the throttle cable to pass through. Place the block in a vise. Hold the cable in the seated position and place the cable in the slot, resting the clevis on the block. Insert a punch (or steel rod) into the clevis and place the tip of the punch on the ball as shown below (right). Strike the punch sharply with a hammer, causing the ball to deform the edge of the softer aluminum clevis. If necessary, repeat this process a few times until the ball no longer catches on the inside of the clevis.
