TO ALL EXEC 90 and EXEC 162F OWNERS

MANDATORY COMPLIANCE BULLETIN M-11

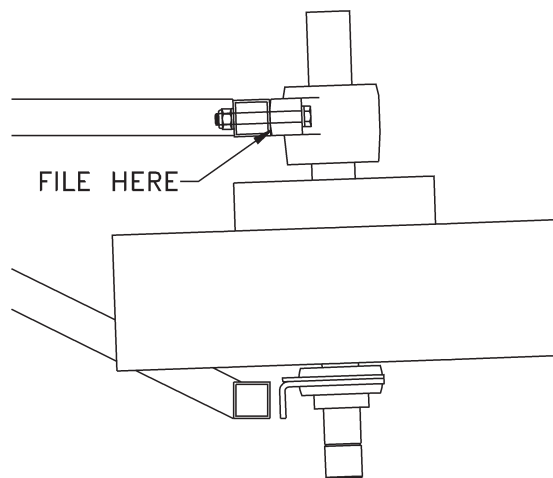
It has come to our attention that some builders have over-tensioned the main drive chain upon installation, in an attempt to avoid having to re-adjust it in the future. We must emphasize that this is a very unsafe practice. Our engineering studies have confirmed that over-tensioning the main drive chain and/or the main drive belts will cause undue stress on the secondary shaft and bearings. This can lead to overheating of the bearings, premature bearing failure, and subsequent failure of the secondary shaft.

1. Level the helicopter so that the square drive mount tubes of the airframe are level both fore/aft and laterally.
2. The large secondary pulley must be level fore/aft and laterally. The secondary should fit against the airframe at the upper and lower mounting locations without having to be forced in place by tightening the bolts. If this cannot be achieved by shimming, file the upper bearing housing at an angle for the correct fit. (See drawing below.) DO NOT FORCE THE UNIT TO FIT AGAINST THE AIRFRAME BY TIGHTENING THE BOLTS OR DAMAGE TO THE SHAFT AND BEARINGS MAY RESULT.
